Manhole Inspection Summary

Manhole # S27M__025MH

Location Address: **1173 W Ostend St** Cross Street: **Washington Bd**

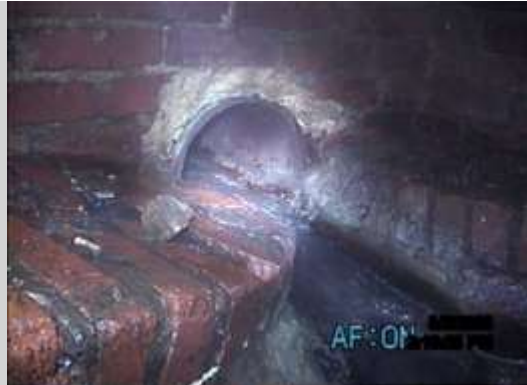
12 O'Clock Outflow

10 in. Circular Gravity Sewer
Pipe Out @ 12 O'Clock

Pipe Height: **3.6** (in.) Rod and Bar (Angled)
Pipe Material: **Clay** ☐ Pipe Lined
Invert Depth: **0.00** (ft.) Flow Characteristics: **Fast**
Deposits: ☒ None ☐ Mud ☐ Gravy ☐ Debris ☐ Grease
Silt Depth: **0** (in.) Deposits Extent:
Infiltration: **None** Pipe Seal Cond: **Unknown**

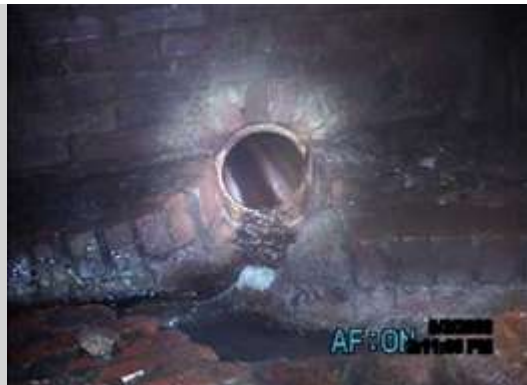
3 O'Clock Inflow

8 in. Circular Gravity Sewer
Pipe In @ 3 O'Clock

Pipe Height: **0** (in.) Direct
Pipe Material: **Clay** ☐ Pipe Lined
Invert Depth: **0.00** (ft.) Flow Characteristics: **None**
Deposits: ☒ None ☐ Mud ☐ Gravy ☐ Debris ☐ Grease
Silt Depth: **0** (in.) Deposits Extent:
Infiltration: **None** Pipe Seal Cond: **Sound**
